# Aravaipa Canyon Geohydrology Assessment

Final Report    September, 2000

**United States Fish and Wildlife Service**  
Contract Number 20181-99-C016

HYDROLOGY & GEOMORPHOLOGY, INC.

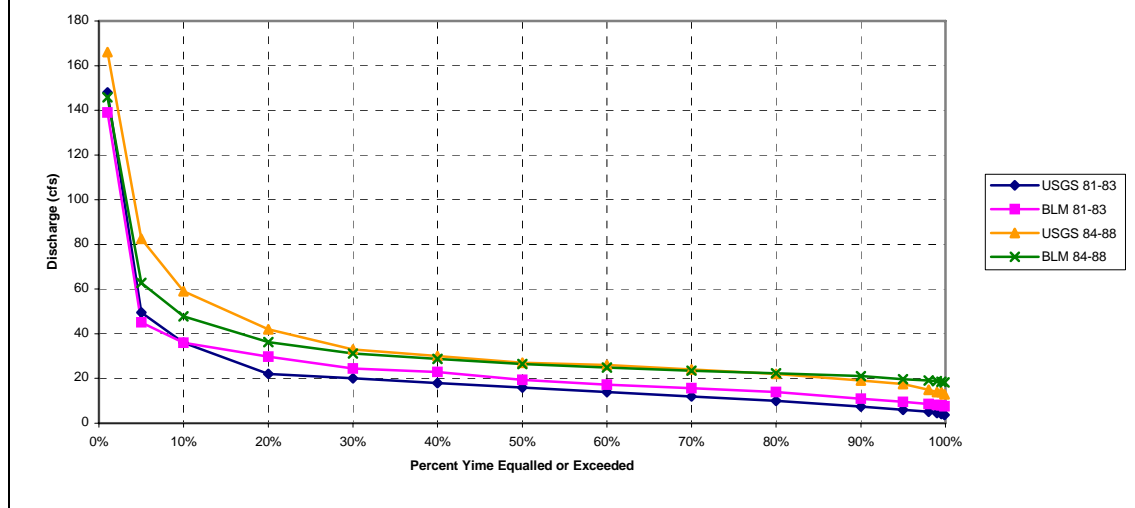
**Figure 3-1. Aravaipa Creek.  
Comparison of USGS & BLM Gage Duration Curves.**

Several conclusions can be drawn from the data shown in Figure 3-1. First, the flow duration curves indicate that the 1984-1988 period was a period of higher sustained flow than the 1981-1983 period. Second, the flow duration curve for the 1981-83 period flows at the BLM gage is consistently higher than the curve for flows at the USGS gage during the same period by approximately 3 cfs (0.1 m<sup>3</sup>/sec) (between 3.2 and 4.5 cfs for flows occurring more than 20% of the time). Third, the flow duration curves for the 1984-1988 period are essentially the same at the BLM and USGS gages, indicating very little difference between flow rates at the two sites. There are variations between the 1984-1988 flow duration curves at the highest (less than 20% of the time) and lowest discharges (greater than 95% of the time). In addition to the increase in sustained discharge, the flows recorded by the two gages came into closer alignment after the 1983 flood.

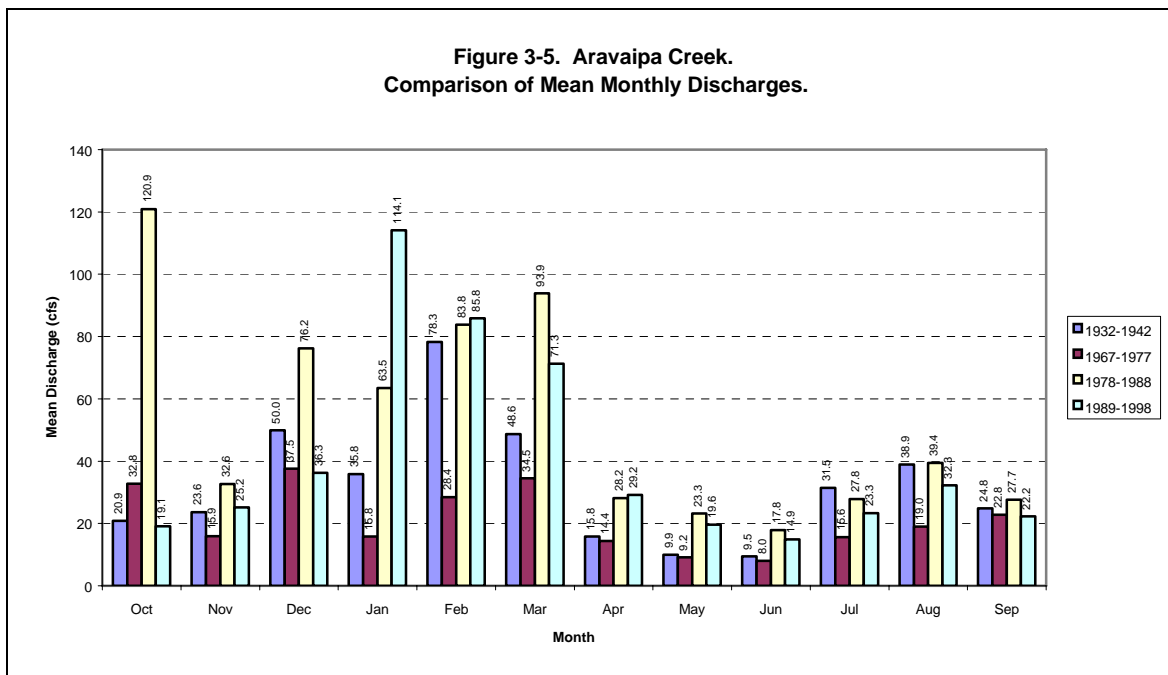
**Long-term Variations in Mean Monthly Discharge.** Mean monthly discharges for each of the four periods described above are presented in Figure 3-5. The discharges that occurred in the two latest periods are generally higher than those that occurred in the first two periods. This pattern suggests that Aravaipa Creek is currently in a wet period. The consistently higher discharge is also apparent in comparisons of base flow, duration curves and yearly volumes discussed in “Long Term Patterns” below.

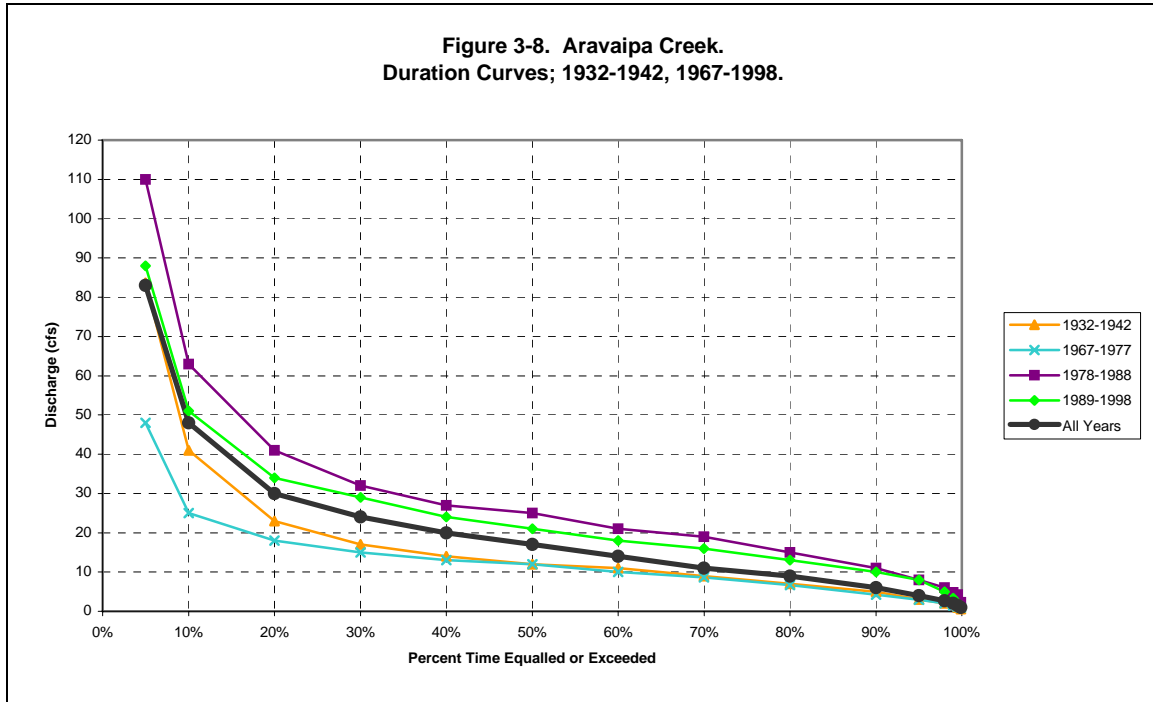
**Changes in Flow Durations Curves.** The duration curves of the four periods can also be compared (Figure 3-8). The earliest periods (1932-42 and 1967-1977) have duration curves that are nearly identical except at high flows experienced less than 20% of the time. The 1978-1988 period shows the highest duration curve. The 1989-1998 duration

curve is slightly lower than the 1978-1988 period curve. The relationship of flow duration curves is similar to the relationship of flow volumes, indicating that Aravaipa Creek is currently in a wet period. Flow duration data for Aravaipa Creek are given in Table 3-9.

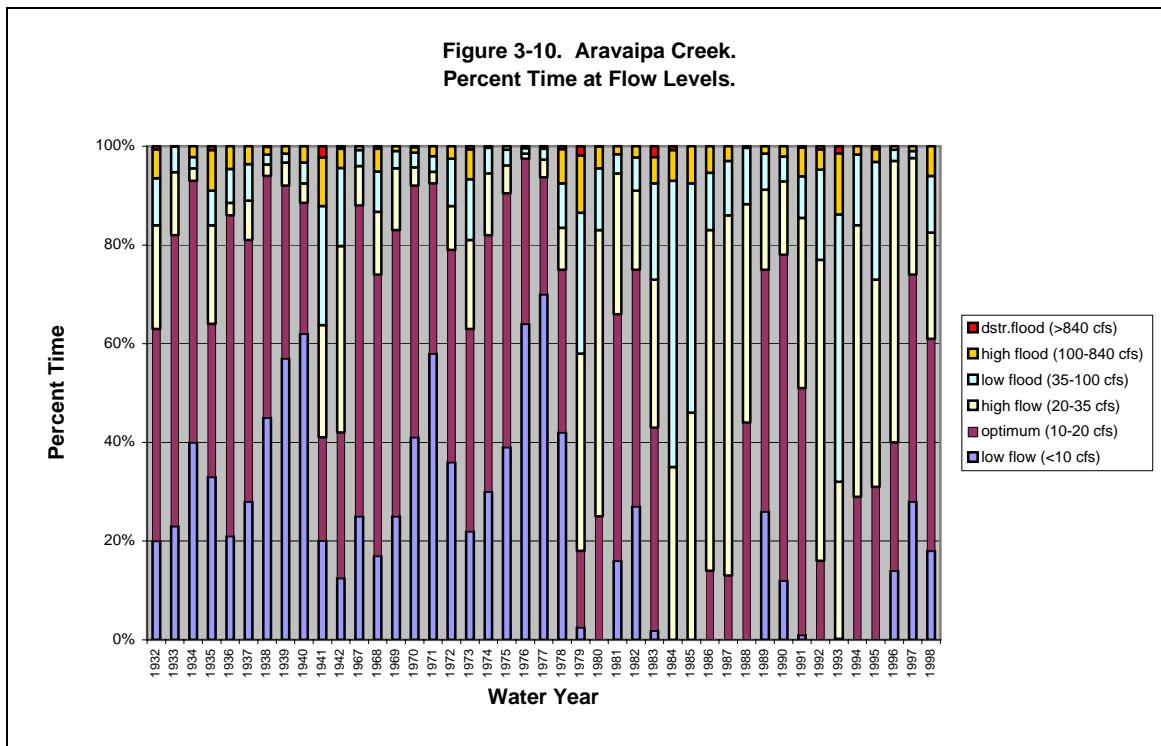
The durations of each of these flow categories are plotted on a cumulative bar graph for visual comparison (Figure 3-10). The long duration of dry years on the left side of the graph is deceptive because water years 1943 through 1966 are not included.

Figure 3-10 illustrates that low flows less than 10 cfs ( $0.3 \text{ m}^3/\text{sec}$ ) were very prevalent in the period prior to 1978. Percent time at which the flow was at optimum levels is generally similar to the low flow duration time. High flows, low floods, high floods, and destructive floods in total generally make up less than 20% of the flow duration in the period prior to 1978. The situation reverses itself in the period after 1978. The percent of time during which Aravaipa Creek is under the influence of high floods is similar to the pre-1978 condition, but destructive floods are more common after 1978. Periods of low floods and high flows are much more common after 1978, punctuated by relatively dry years approximately every seven years (1981 & 1982, 1989 & 1990, 1997 & 1998). The dry years follow a year of below average precipitation: 12.22 inches (31.04 cm) in 1981; 11.10 inches (28.19 cm) in 1989; 9.05 inches (22.99 cm) in 1996 (Figure 3-13). Continued monitoring of discharge levels is appropriate to determine whether the apparent seven-year pattern of alternating wet and dry cycles is maintained or whether the dry pre-1978 pattern will return.

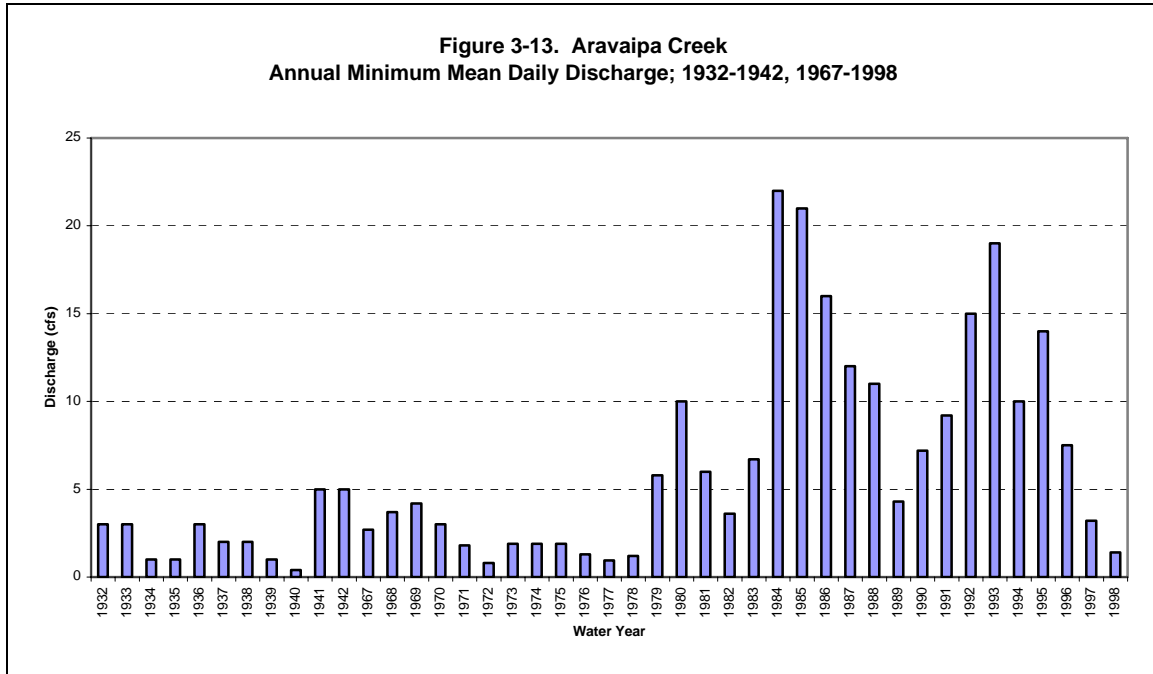
Annual mean daily minimum flows recorded by the USGS gage are illustrated in Figure 3-13. The mean daily minimum flows have increased dramatically after 1978.

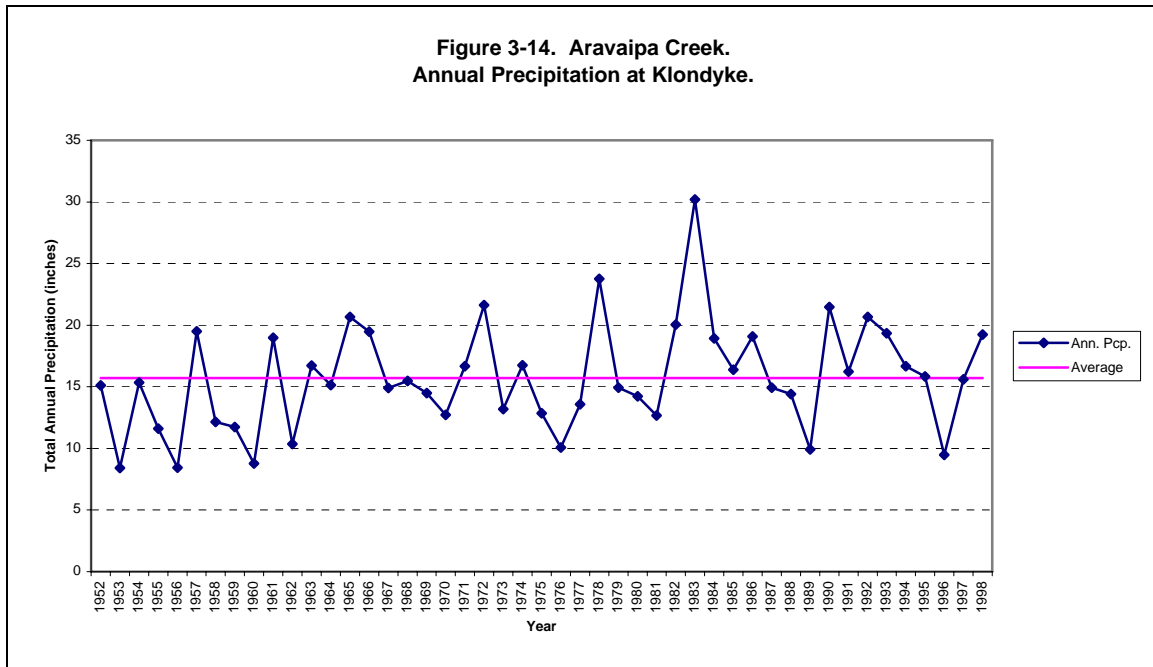
Total annual precipitation is presented in Table 3-20 and is shown on Figure 3-14. The average total annual precipitation at Klondyke is about 15.72 inches (39.93 cm) for the entire period of record. The driest year on record was 1953 with only 8.41 inches (21.36 cm); the wettest year was 1983 with 30.19 inches (76.68 cm). The annual rainfall totals trend slightly upward over the last 47 years. Comparisons of the average total annual precipitation can be made for periods similar to those used in the USGS gage data analysis (Table 3-21). The two most recent periods are slightly wetter than the two earliest periods. The percentage of years in which total annual precipitation was above average also increased over time. These trends correlate well with the increased discharges seen in the USGS gage record.

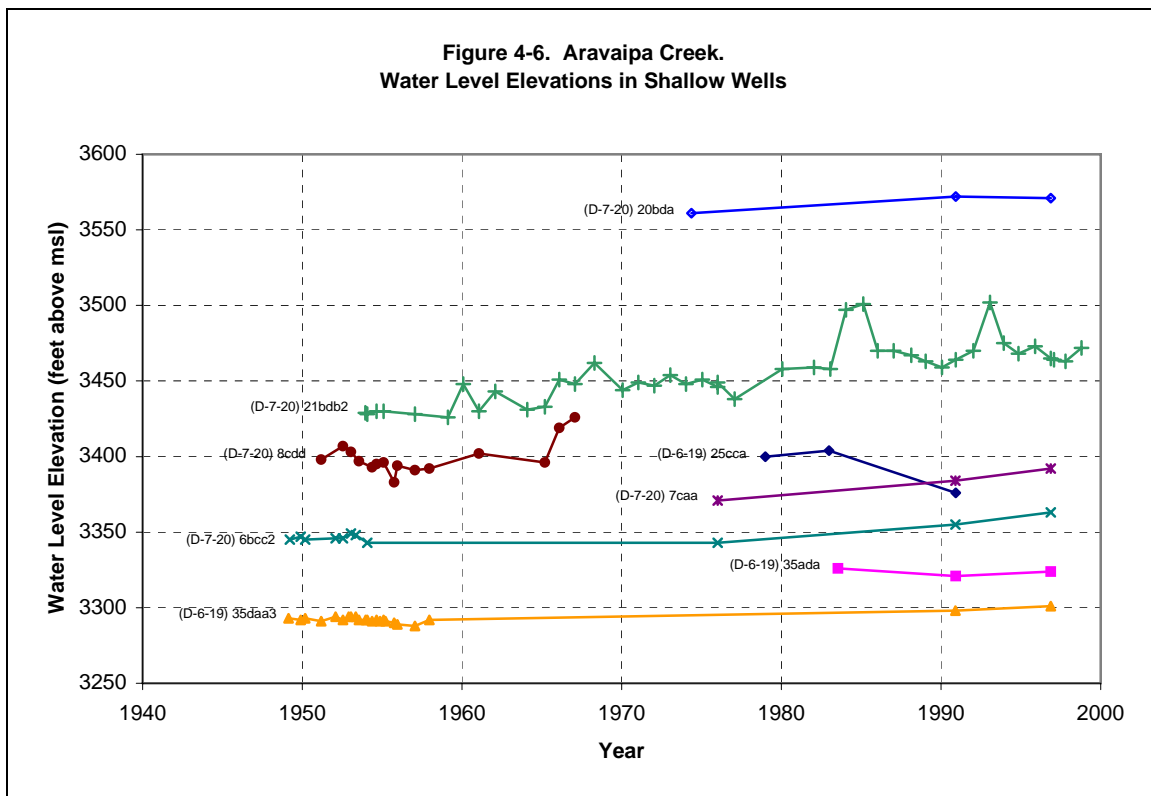
An overall estimation of the impacts of groundwater use can be made from water level measurements taken from wells over time. Figure 4-6 shows water levels in shallow wells over a period of years from 1949 to 1998. Shallow wells are those less than 150 feet deep. Shallow wells for which sufficient data were available are all located along Aravaipa Creek upstream of the canyon. Although changes in the water levels are modest, most of the wells demonstrate a slight increase in groundwater levels between

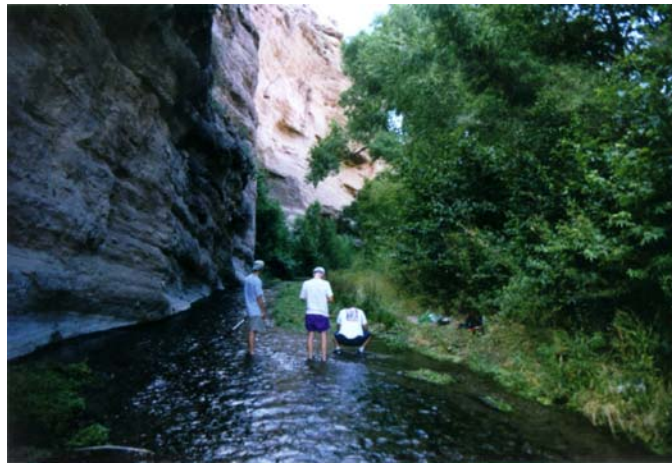
***Cross Section AC-1.*** Three pairs of photos best illustrate the changes that occurred at cross section AC-1 just upstream of Turkey Creek (Figures 5-1). The first pair (Figures 5-6a and 5-6b) looks upstream toward the BLM gage (not visible in photographs). The island near the left bank (photo right) appears to have moved downstream since July and has been split by flow. Some of the vegetation in the photo background has changed slightly. Several trees visible in the July photo (Figure 5-6a) are not present in the November photo (Figure 5-6b). Although the trees have lost most of their foliage, which can be deceiving, close examination reveals that several trunks were removed between July and November. Several discharge events between July and November may have contributed to the removal of the bar material and removal of the trees and other vegetation. The single 4,150 cfs (118 m<sup>3</sup>/sec) instantaneous event of July 28, 1999, may have removed the gravel bar and the covering vegetation. Alternately, the combination of the larger flood with several smaller floods may have cumulatively affected the bar, resulting in the observed changes.

**Figure 5-6a. Looking upstream at cross section AC-1. Photo date: July 2, 1999.**

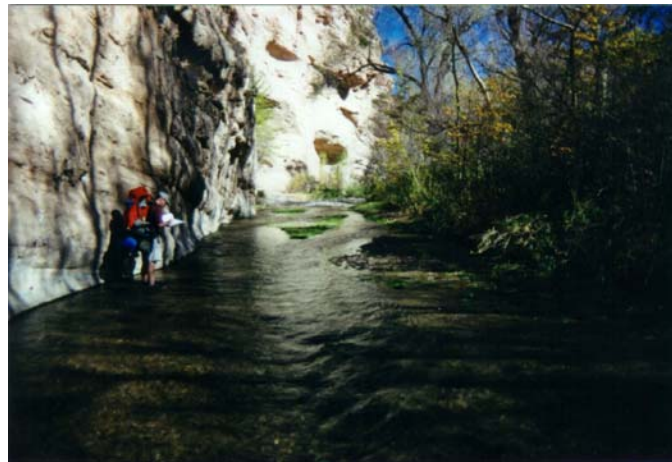
**Figure 5-6b. Looking upstream at cross section AC-1. Photo date: November 19, 1999.**

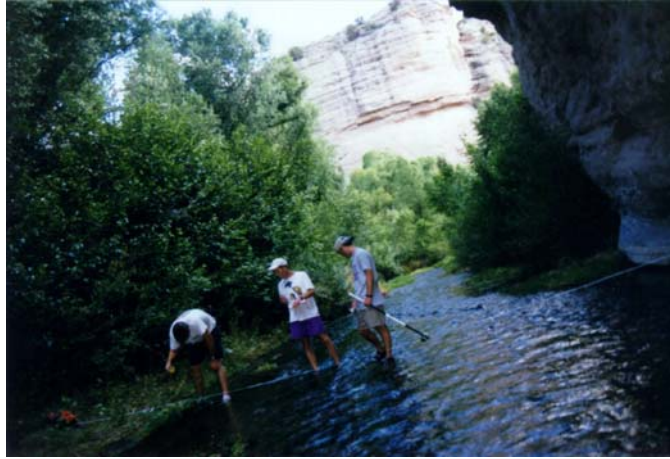
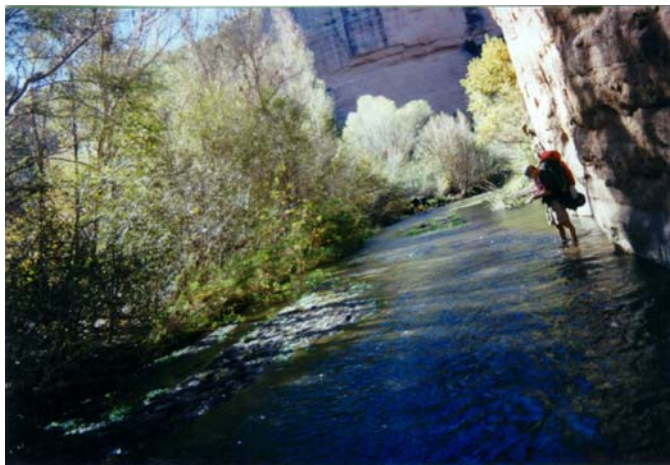
Looking downstream in figures 5-7a and 5-7b, the most obvious difference is that the right bank (photo right) bar and vegetation was completely eliminated due to the flows that occurred between July and November. An additional change to the streambed is the new mid-channel island (bar) in the center of the channel downstream.

**Figure 5-7a. Looking downstream at cross section AC-1. Photo date: July 2, 1999.**

**Figure 5-7b. Looking downstream at cross section AC-1. Photo date: November 19, 1999.**

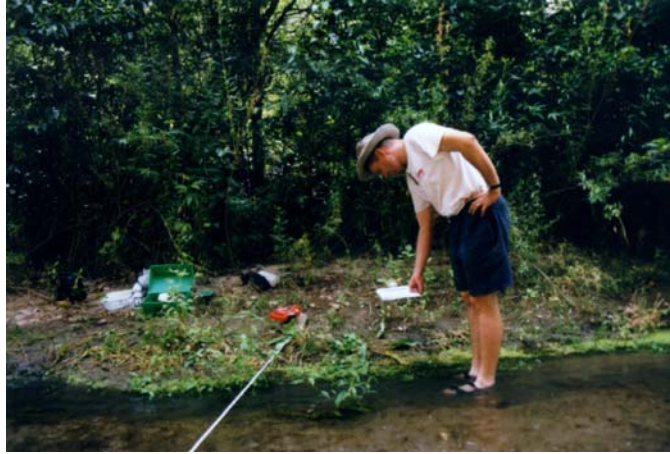
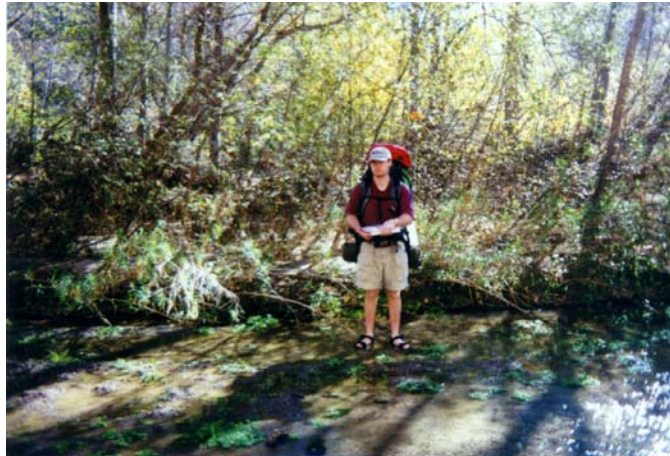
The third set of photos illustrating the changes that occurred in this portion of Aravaipa Creek focuses on the left bank (Figures 5-8a and 5-8b). In July, the water's edge is several feet from the larger vegetation, at the base of a gradual slope down to the water surface. In November, the larger vegetation is nearer the water's edge. The bank slope has changed from a gradual slope to a steeper cutbank. Additionally, although the water surface elevation in November was slightly higher than in July, based on waterline on right bank bedrock in photos the left side of the channel visible in the photos is shallower in November than in July.

**Figure 5-8a. Looking at cross section AC-1 left bank. Photo date: July 2, 1999.**

**Figure 5-8b. Looking at cross section AC-1 left bank. Photo date: November 19, 1999.**

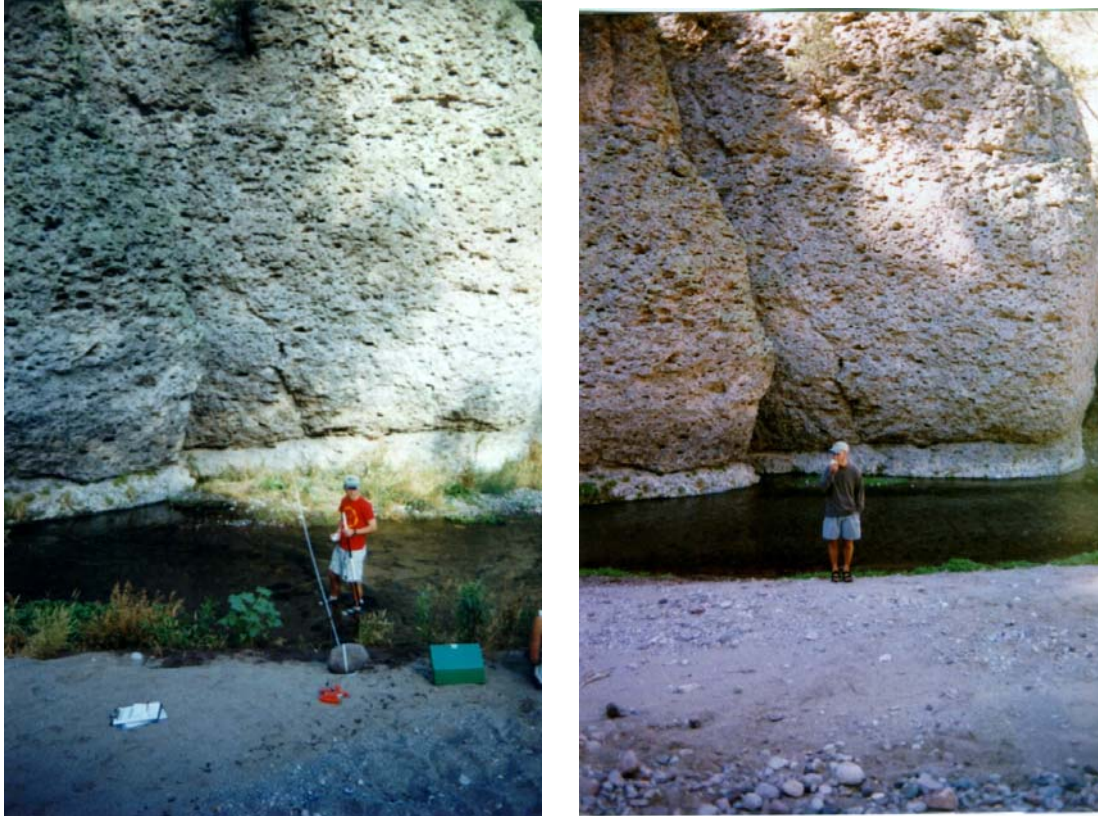
Figures 5-9a and 5-9b look across Aravaipa Creek, directly at the left bank. The vegetated bar on the left bank, in front of the bedrock outcrop, is no longer present in the November photo. These figures illustrate the amount of sediment in the bar that had to be moved by the flows between July and November. The particle size on the right bank in the foreground of the photos is also of interest. Note that there are more large particles visible on the surface of the bank in November than in July. The change in particle size

distribution on the surface hints at the mobility of the sediments that are not in the creek bed itself. The bar must have been inundated at some time between July and November and been subjected to flow that caused the movement of the particles.

**Figures 5-9a (left) and 5-9b (right). Looking at left bank, cross section AC-2. 5-8a Photo date: July 3, 1999. 5-8b Photo date: November 20, 1999.**

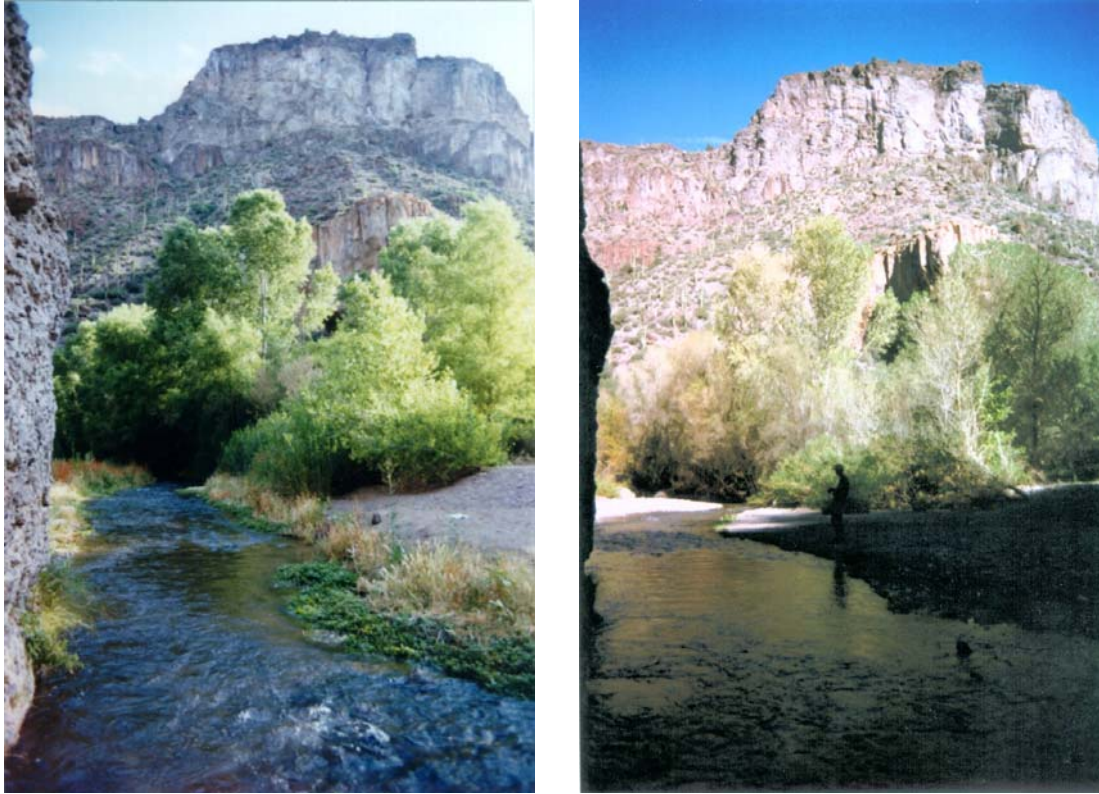
A second view of this portion of Aravaipa creek focuses on the right bank looking downstream (Figures 5-10a and 5-10b). Bank vegetation has changed considerably from July to November. The grassy vegetation mat present in July is not present in November. The change is most likely due to scour and not seasonal changes, since no evidence of dead or dormant vegetation is present in the November photo. Any sediment under the plants in the July photo also appears to have been washed away, as the shape of the bank is slightly different. The slope of the bank has also changed. The slope in November has a more gradual slope down to the water rather than the steeper slope break apparent in July.

Figures 5-10a (left) and 5-10b (right). Looking downstream at cross section AC-2. 5-9a Photo date: July 3, 1999. 5-9b Photo date: November 20, 1999.

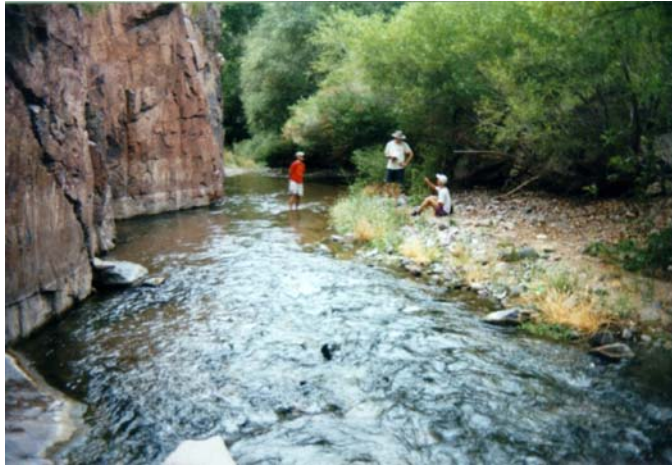
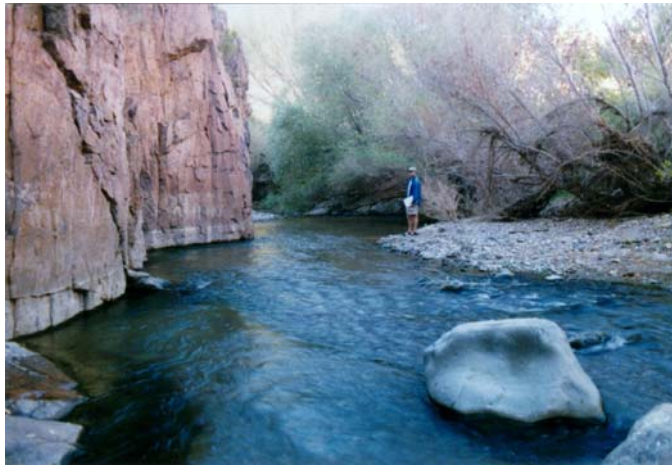
Figures 5-11a and 5-11b illustrate some of the changes that occurred at this cross section. The cobble size on the right bank bar remains consistent between the two photos. Visual matching between the original photos indicates, however, that individual rocks moved slightly between July and November. Vegetation has also changed dramatically. Just as at cross section AC-2, the changes are more likely due to scour rather than seasonal changes as no dead or dormant vegetation remains along the bank.

**Figure 5-11a. Looking downstream at cross section AC-3. Photo date: July 4, 1999.**

**Figure 5-11b. Looking downstream at cross section AC-3. Photo date: November 20, 1999.**

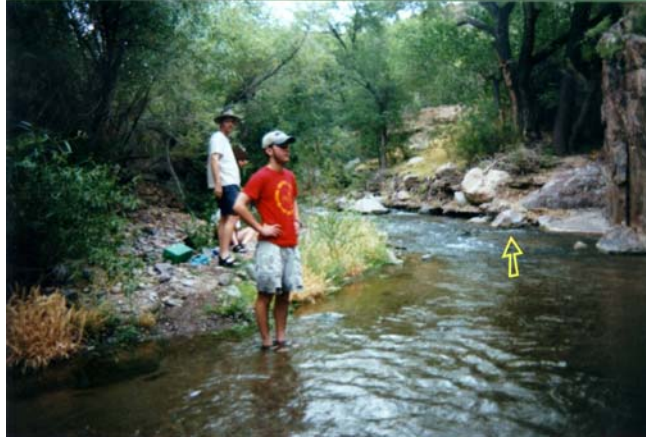
There is a riffle/rapid sequence with large boulders just upstream of cross section AC-3 (Figures 5-12a and 5-12b). A large boulder visible in the photo rests against the right bank in the July photo (Figure 5-12b). In the November photo this boulder can be seen resting in the center of the channel (Figure 5-12a). Based on field measurements this boulder moved approximately eight feet. Other boulders of similar size did not move. The high flows that occurred between July and November may not have moved the boulder directly. The flows may have moved material that the large boulder was resting on, thus undermining the boulder and causing it to move.

**Figure 5-12a. Looking upstream at cross section AC-3. Photo date: July 4, 1999. Yellow arrow indicates boulder that moved between July and November.**

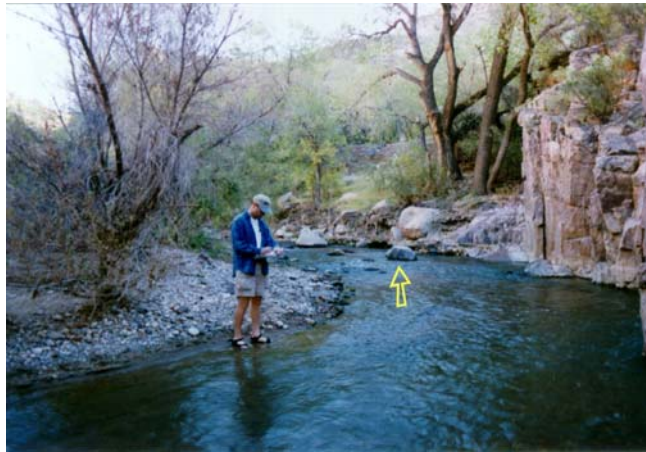
**Figure 5-12b. Looking upstream at cross section AC-3. Photo date: November 20, 1999. Yellow arrow indicates boulder that moved between July and November.**

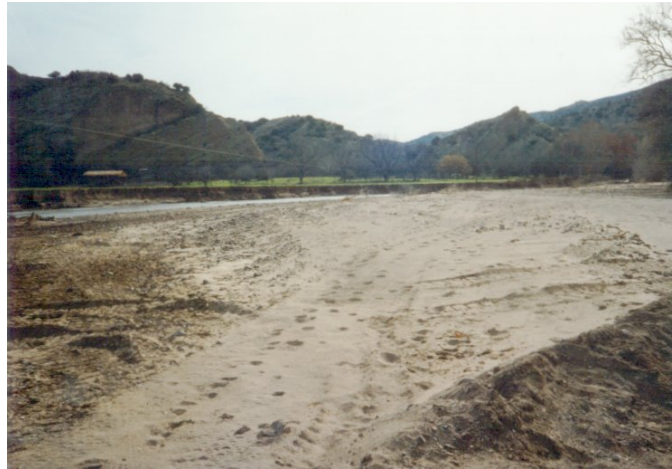
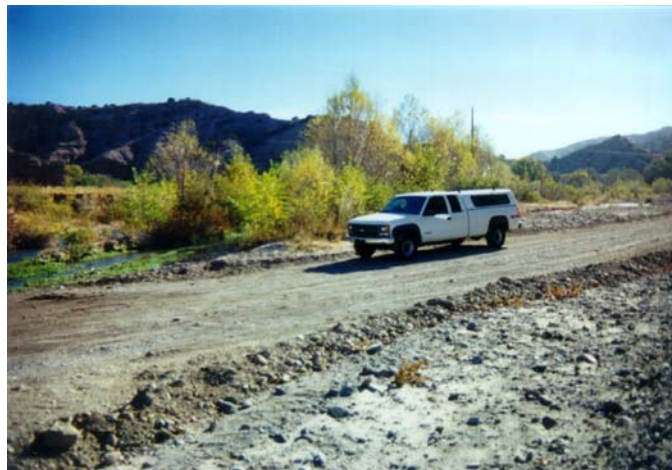
***The Nature Conservancy Manager's Crossing.*** The Nature Conservancy Manager's crossing (Figures 5-13a and 5-13b) was photographed in 1993 and 1999. The 1999 photographs illustrate that the riparian vegetation is capable of recovering in a relatively short time span. Young trees including cottonwoods were located on the left bank (closer to photo point-of-view) and a mid-channel bar in 1999. The exposed cut bank on the right bank was also vegetated by grasses. The vegetation provides some measure of erosion control, at least against the discharges that occurred between 1993 and 1999.

**Figure 5-13a.** 1993 view, looking upstream and at the right bank of Aravaipa Creek at TNC manager's crossing.

**Figure 5-13b.** 1999 view, looking upstream at right bank of Aravaipa Creek at TNC manager's crossing.

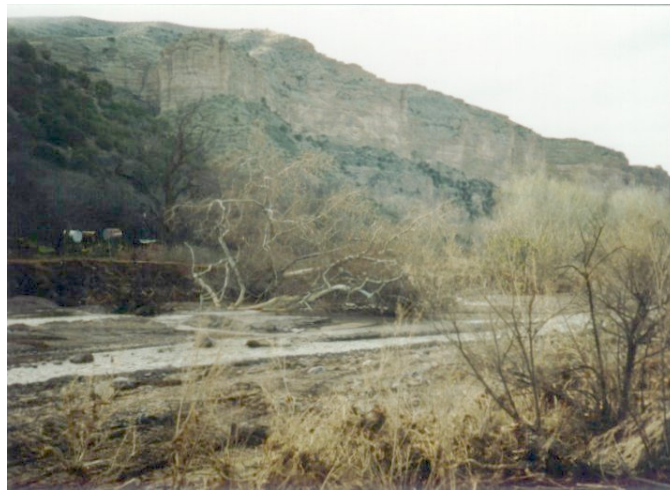
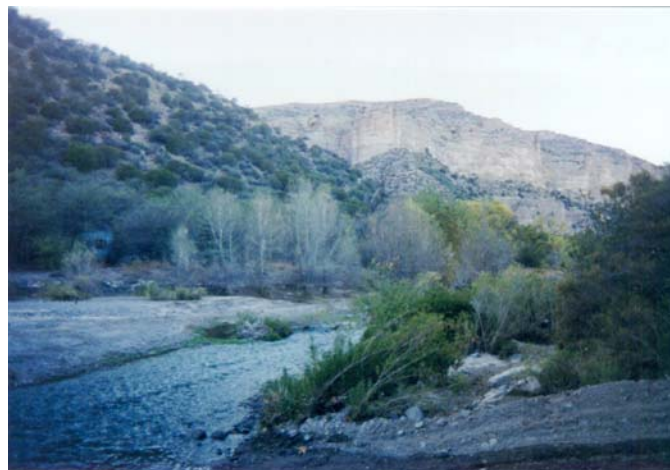
The photographs also show that while the riparian vegetation is recovering along the high flow channel, the low flow channel is moving laterally and changing its course. Upstream of the road crossing the stream moved away from the right bank, as there is a noticeable distance between the cut bank and the new riparian vegetation (Figure 5-13b). Downstream of the road crossing the channel moved closer to the right bank (photo right in Figures 5-14a and 5-14b). Aravaipa Creek has also turned from a sediment choked braided creek as seen in 1993, to a single channel in 1999.

**Figure 5-14a. 1993 view looking downstream at the left bank of Aravaipa Creek at TNC Manager's crossing.**

**Figure 5-14b. 1999 view looking downstream at left bank of Aravaipa Creek at TNC manager's crossing.**

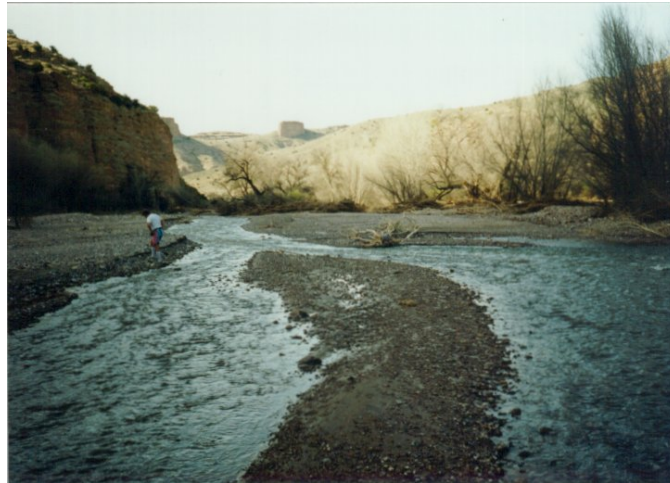
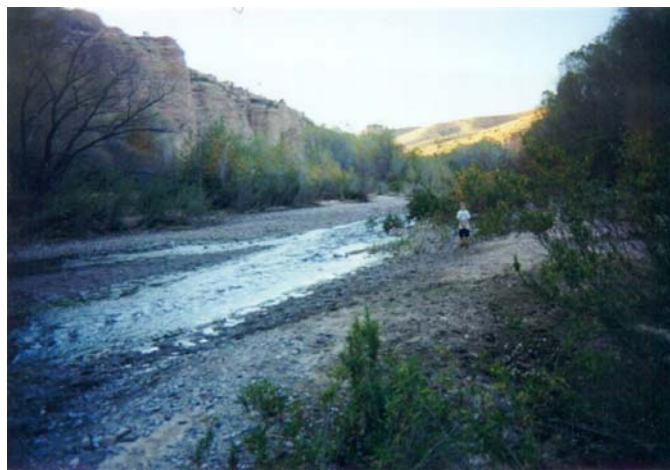
***Chimney Rock Vicinity.*** Figures 5-15a, 5-15b, 5-16a, and 5-16b are photographs of Aravaipa Creek in 1993 and 1999 near Chimney Rock. Comparison of the photos reveals that only minor channel changes have occurred in the last six years. The size distribution of bed material appears to have remained the same. The channel has experienced some minor shifts in lateral position, but a mid channel bar visible in 1993 is also visible in 1999 (Figures 5-15a and 5-15b).

**Figure 5-15a.** 1993 view looking downstream Aravaipa Creek in the vicinity of Chimney Rock.

**Figure 5-15b.** 1999 view looking downstream Aravaipa Creek in the vicinity of Chimney Rock.

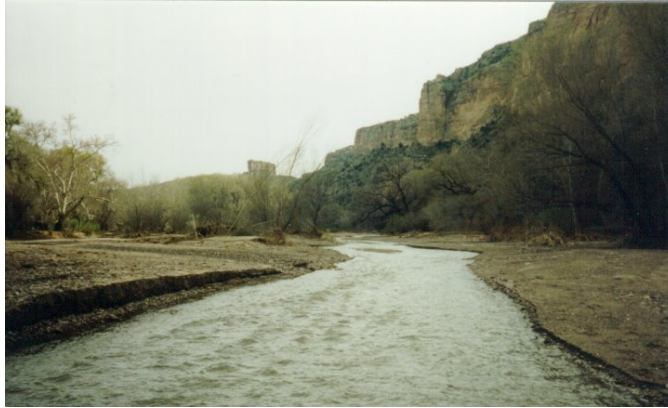
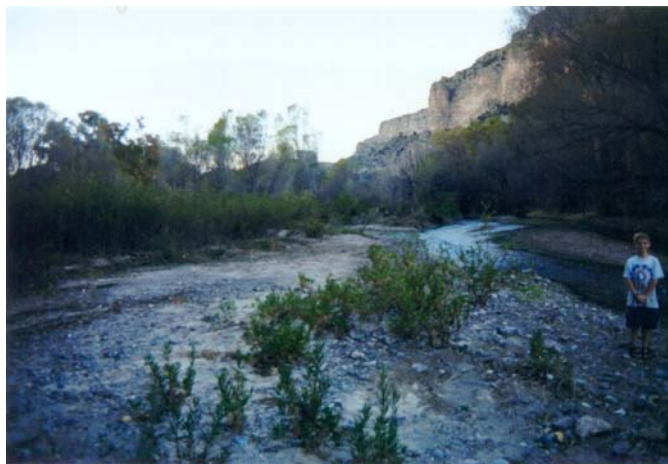
In Figure 5-16a, a small cut bank is visible on the right bank of the channel (photo left). By 1999 (Figure 5-16b) the bank has assumed a gentler slope, and the channel has shifted its course slightly to the left (photo right). There has also been some growth of small near-channel vegetation between 1993 and 1999. Overall not much change occurred on this reach of Aravaipa Creek between 1993 and 1999.

**Figure 5-16a. 1993 view looking upstream Aravaipa Creek in the vicinity of Chimney Rock.**

**Figure 5-16b. 1999 view looking upstream Aravaipa Creek in the vicinity of Chimney Rock.**

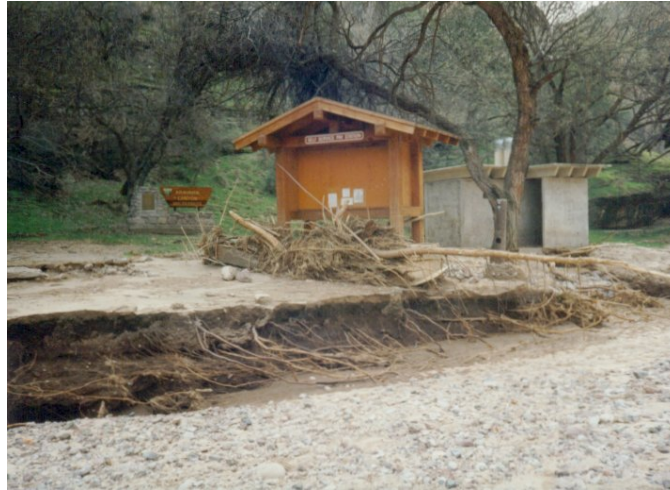
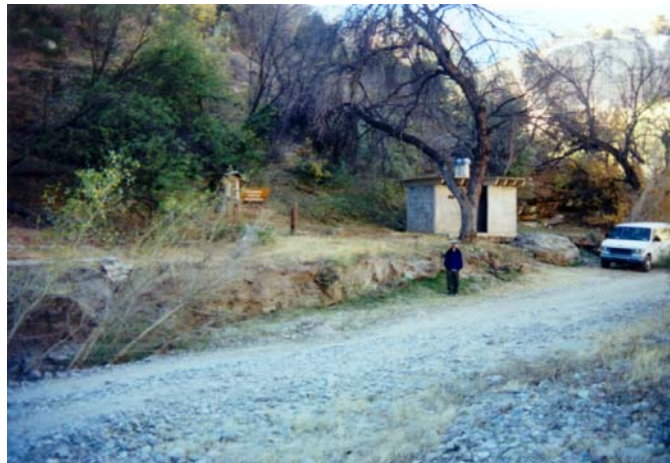
***East Entrance of Aravaipa Wilderness Area.*** The third area in which photographic views were recreated is located at the east entrance to Aravaipa Wilderness. The flood of 1993 apparently eroded parts of the high terrace bank extensively, as suggested by the exposed roots in Figure 5-17a. By 1999 (Figure 5-17b) the cut banks had become less severe, probably helped along by maintenance crews removing the exposed roots. The 1993 flood did not visibly damage the larger trees on the terrace. Surface vegetation along the cut bank was completely ripped out, however. By 1999 vegetation had grown back on the terrace surface and along the base of the terrace bank. Small saplings are also visible along the terrace bank consistent with the size of new trees upstream at TNC manager's crossing. The high-water mark indicated by flotsam in the 1993 photo was approximately eight feet (2.4 m) above the road surface.

**Figure 5-17a. 1993 view; east boundary of Aravaipa Canyon Wilderness Area.**

**Figure 5-17b. 1999 view; east boundary of Aravaipa Canyon Wilderness Area.**

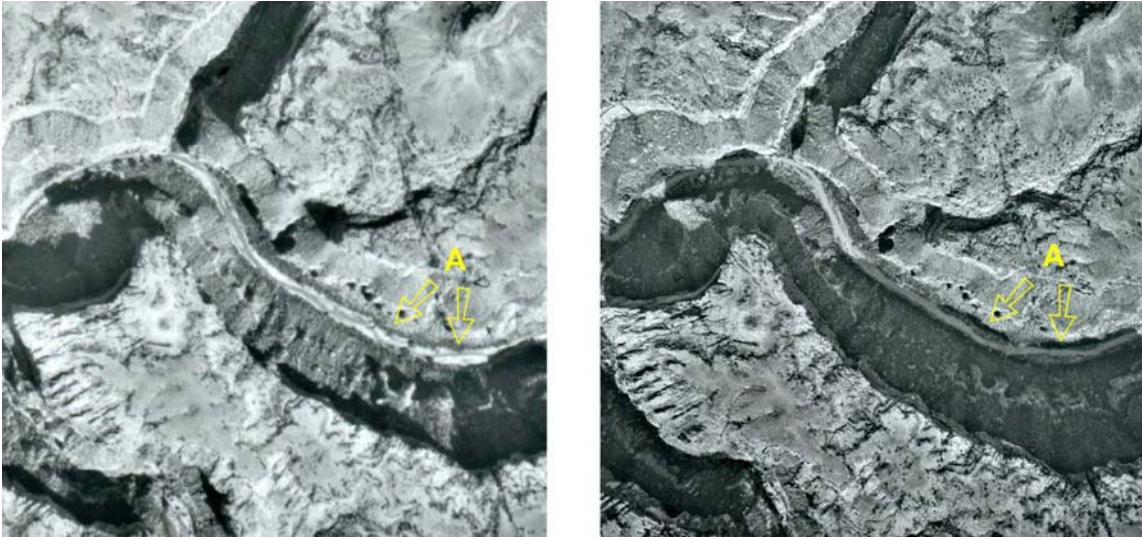
**Horse Camp Canyon.** Changes in this section of Aravaipa Creek are generally manifested as the formation and revegetation of bars associated with the creek's recovery after the October 1983 flood (Figure 5-31). After the October 1983 flood, the channel flowed through a band of unvegetated sandy to gravelly material. Within the channel, Aravaipa Creek occasionally took on a braided pattern after the 1983 flood. Two bars that had been stripped bare by the 1983 flood had been revegetated by 1993 (A). The most downstream of these bars appears to have increased in size slightly to approximately 69 ft (21 m) at its widest. In conjunction with the bar's increase in size, Aravaipa Creek appears to have shifted slightly towards the left bank.

Figure 5-31. Comparison of 1984 and 1993 photos near Horse Camp Canyon. 1984 photo is on left. 1993 photo is on right.
